Problems

Paint/bodywork

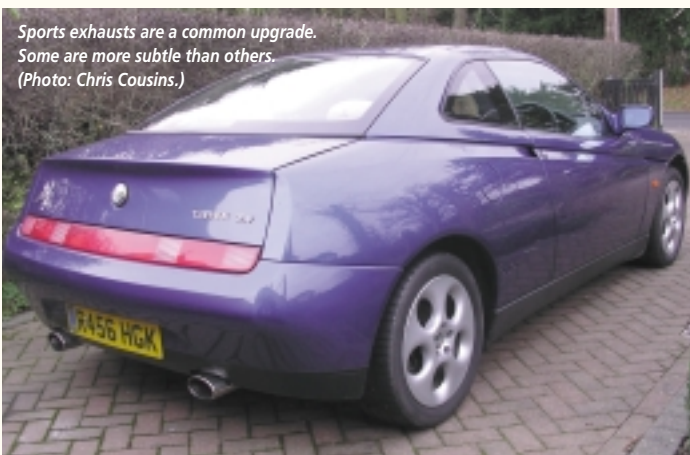
Sports exhausts are a common upgrade. Some are more subtle than others. (Photo: Chris Cousins.)
